Incident Investigation,  
Department 233, 3-16-87

Incident Investigation  
Department 233

Date of Incident: February 5, 1987  
Time of Incident: 2:30 p.m.  
Location: Department 233  
Sewer Outflow  
Type of Incident: Hot sewers  
Most Probable Cause: Faulty level indicator  
in Item 203.

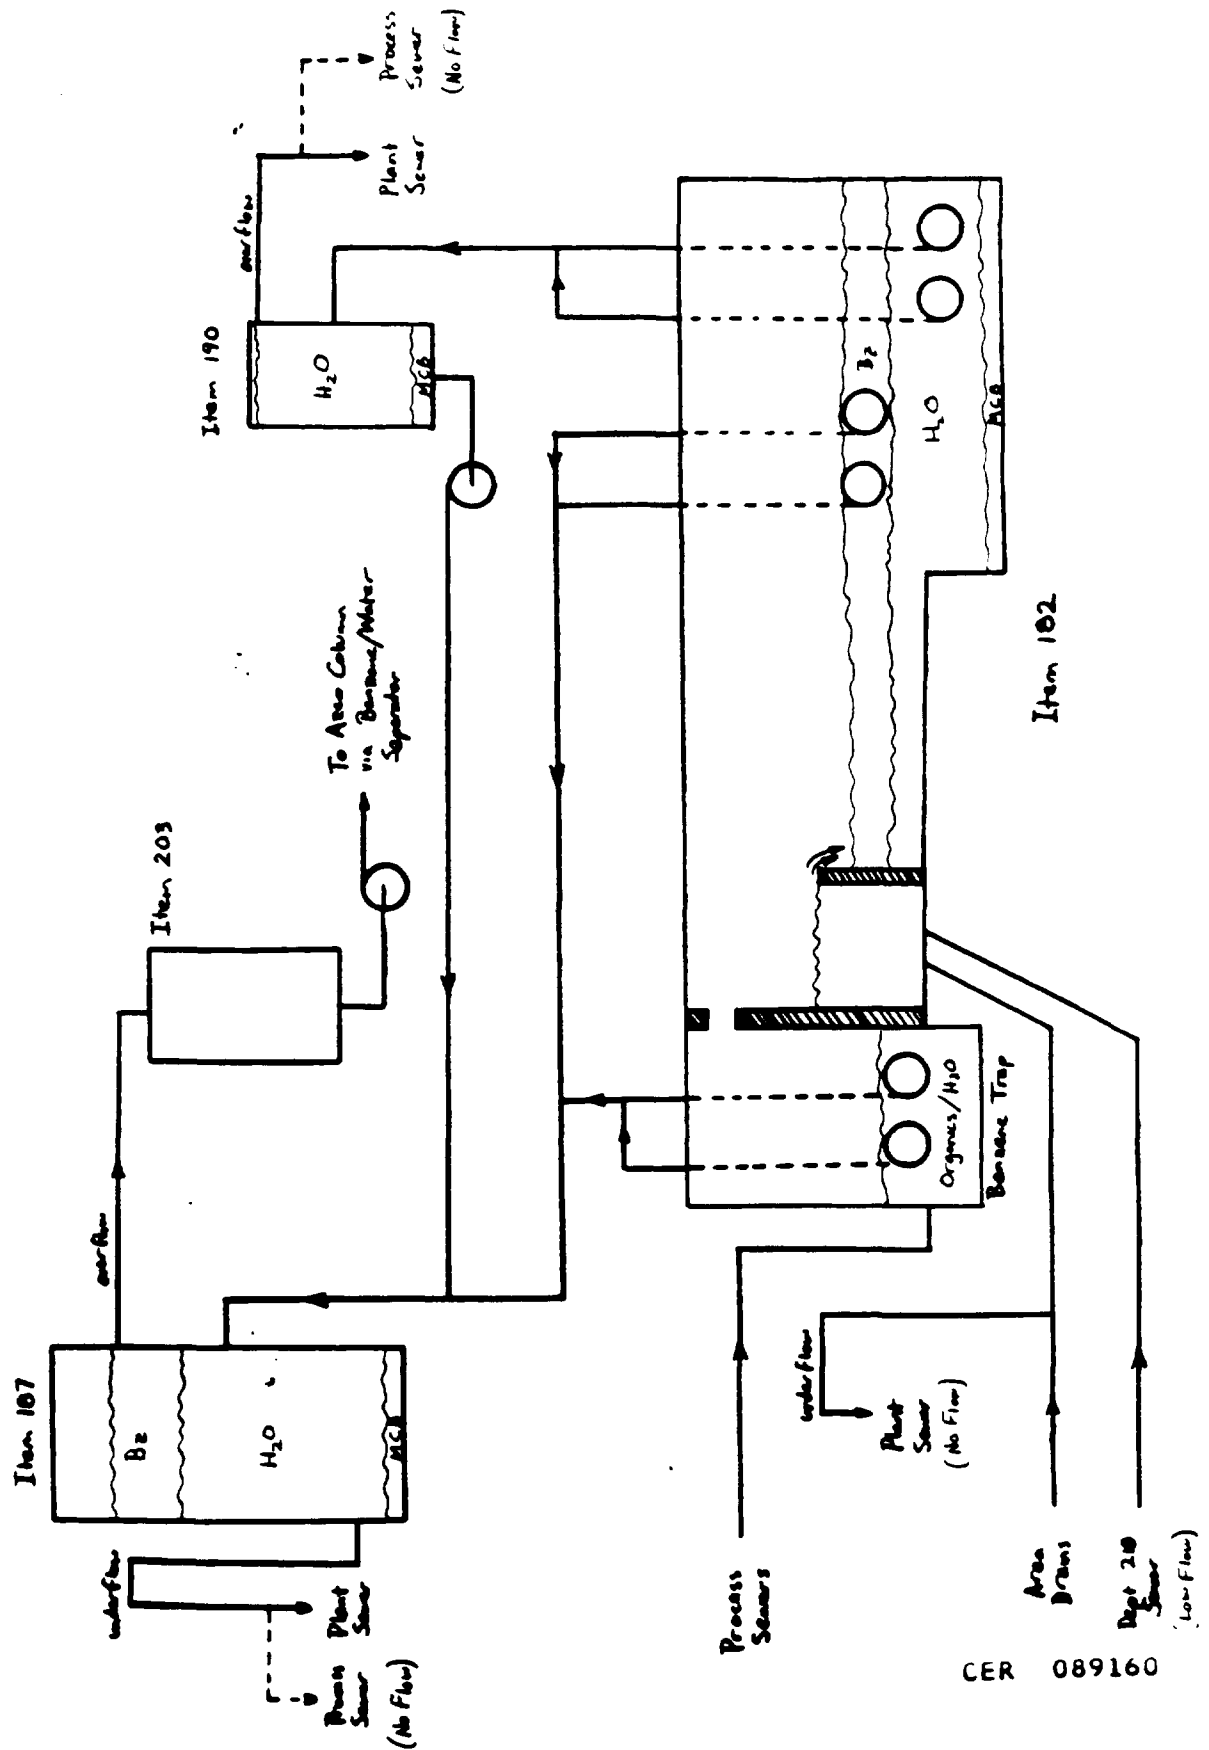
FIGURE 1. DEPT 233 SEWER COLLECTION SYSTEM

The purpose of the Collection Pit is to collect, contain, and gravity separate all process fluids draining from the MCB and Muriatic Acid (Department 218) operating facilities. The Pit is made up of three compartments (Figure 1). The first and northernmost compartment, the Benzene Trap, collects flows from the process drain system. This system includes benzene-contaminated streams coming from the Benzene/Water Separator, Item 113 (aqueous drain) and Separator Vent Scrubber, Item 131 (effluent), in addition to process equipment drains. The Benzene Trap is level-controlled and pumped to the Collection Tank 187; the Benzene Trap may overflow into the middle compartment of the Pit during high flow conditions or pump/instrument failure.

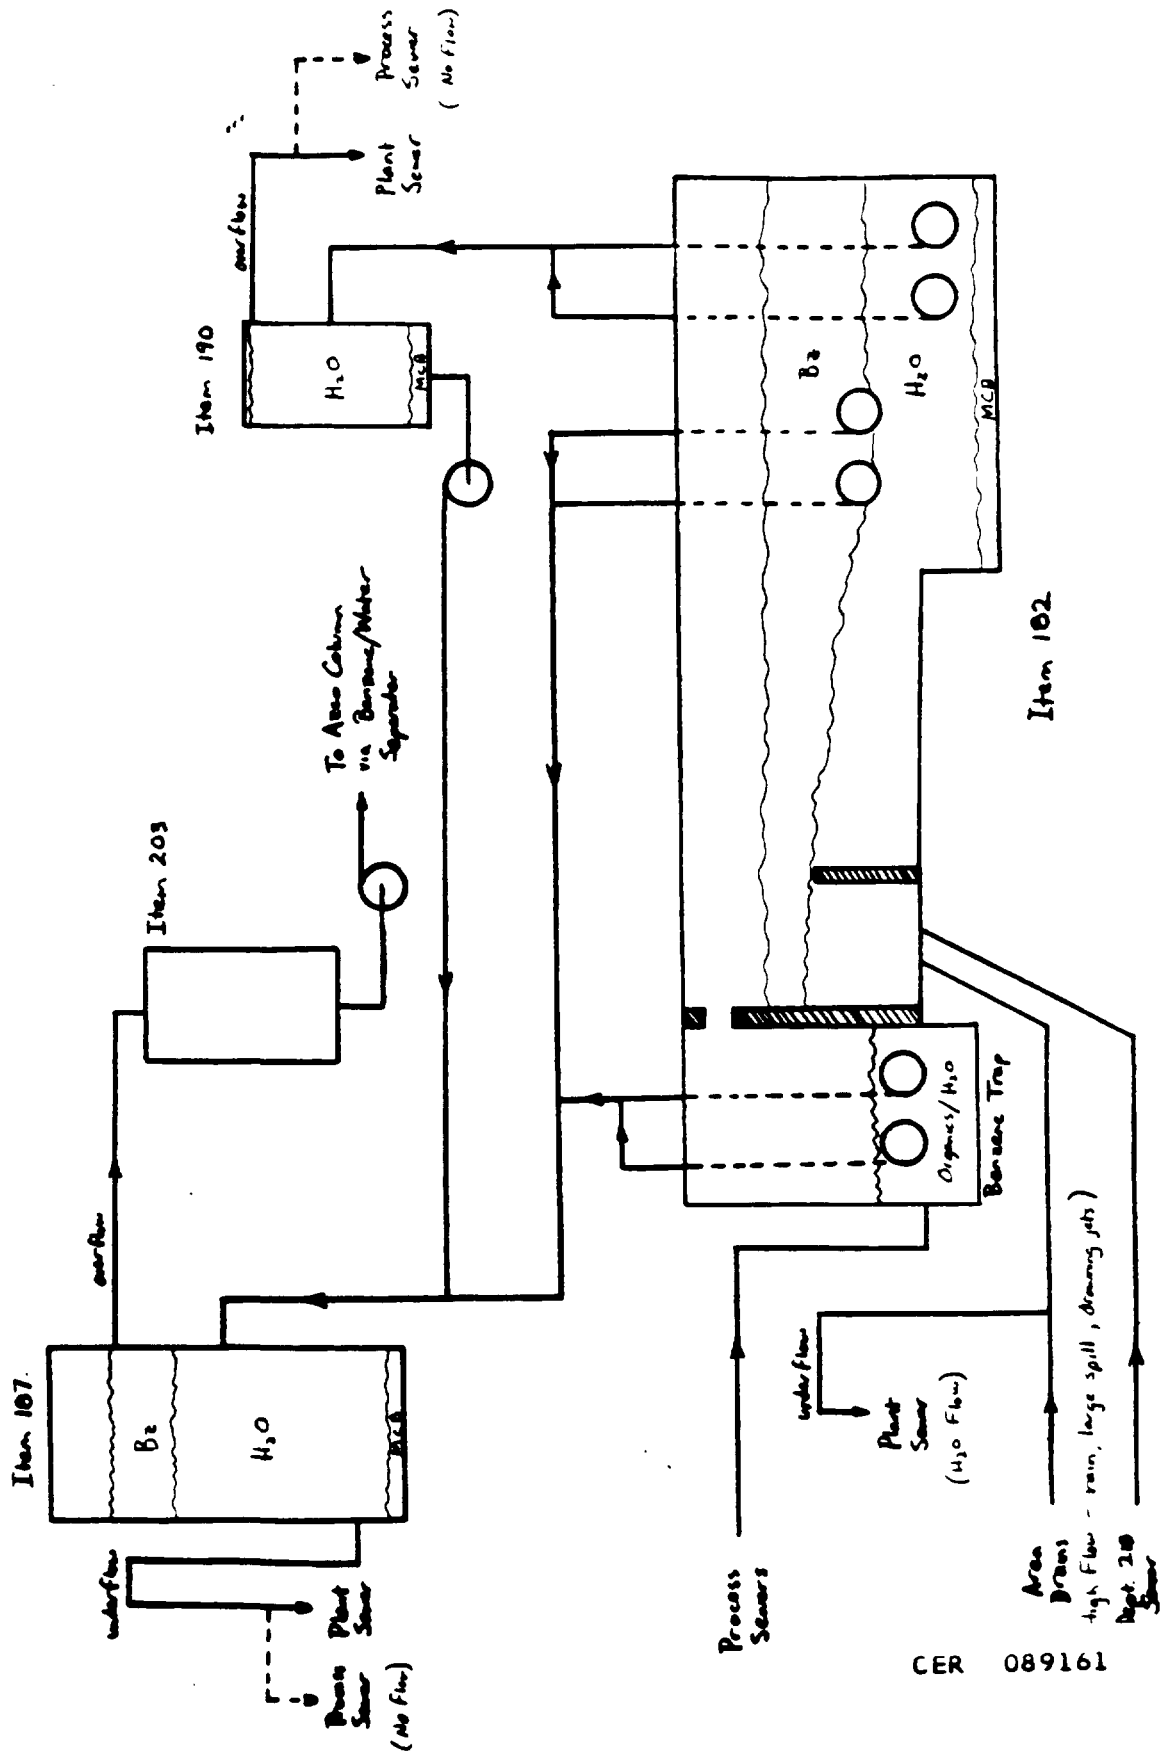
FIGURE 2. DEPT 233 SEWER COLLECTION SYSTEM  
HIGH FLOW OPERATION

The second and middle compartment of the Collection Pit, the Middle Pit, receives the flows from the area drains and Department 218. Under design conditions, these flows are relatively low, and the Middle Pit overflows into the third and southernmost Pit compartment, the Pit South End. However, a high load condition can occur when Department 218 is drowning acid, or with a heavy rain or large spill (Figure 2). Under this condition, the South End pit pumps cannot keep up with the flow, and the South End level rises to 100%, stopping overflow from the Middle Pit. At levels above 100%, mid-level contents of the Middle Pit underflow to the plant sewer; this is the first point from which aqueous wastes can exit the process area (Figure 3).
